# 旧山古志村付近の宅地地盤状況写真

調査期間：2005年5月13-15日  
調査者：太田英将@太田ジオリサーチ  
(土木学会斜面工学研究小委員会の調査)

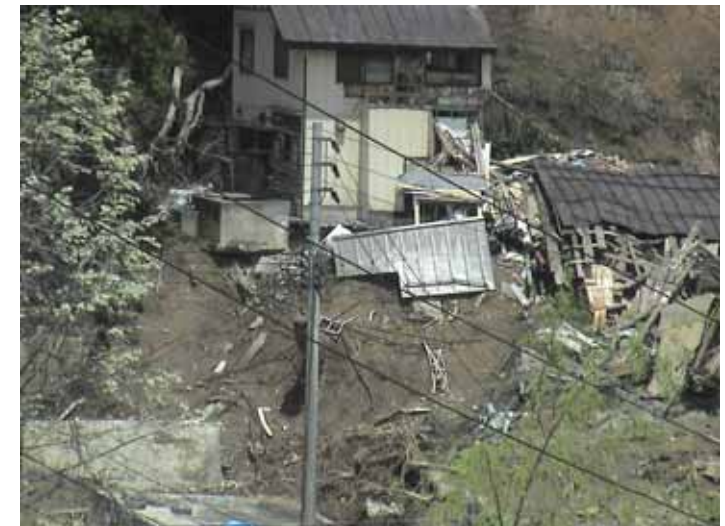
23-02池谷DSC00074.JPG  
2005/05/14 11:02:26  
盛土部の崩壊

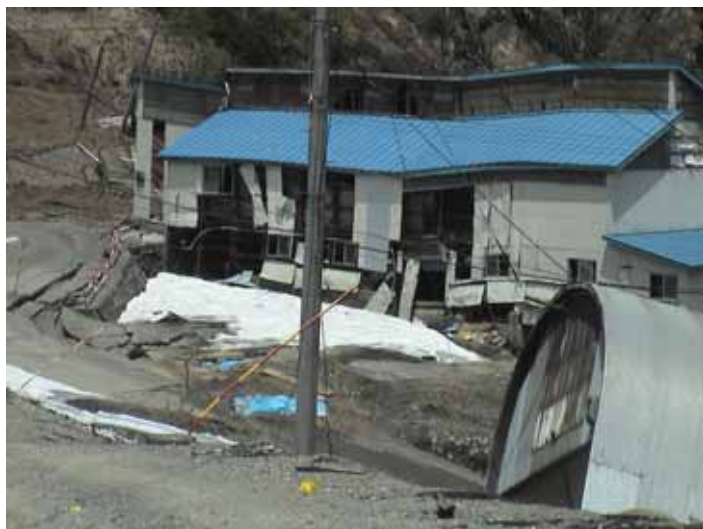
23-03池谷DSC00075.JPG  
2005/05/14 11:02:35  
谷部の盛土上の建物

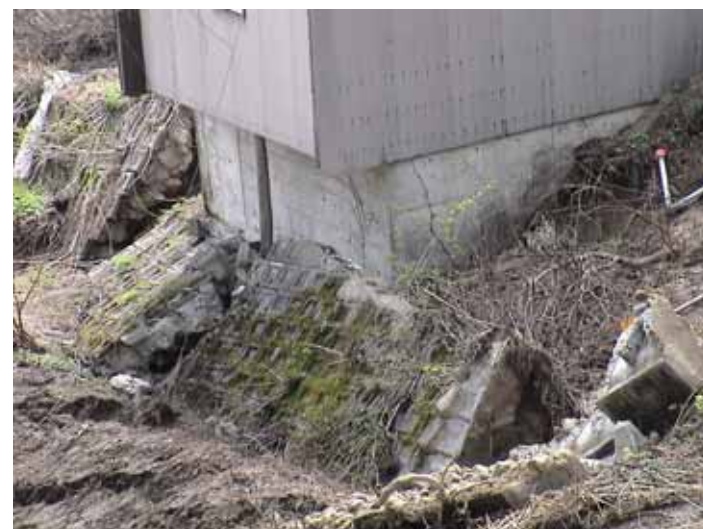
23-09池谷DSC00086.JPG  
2005/05/14 11:08:11  
ブロック積擁壁の盛土部崩壊

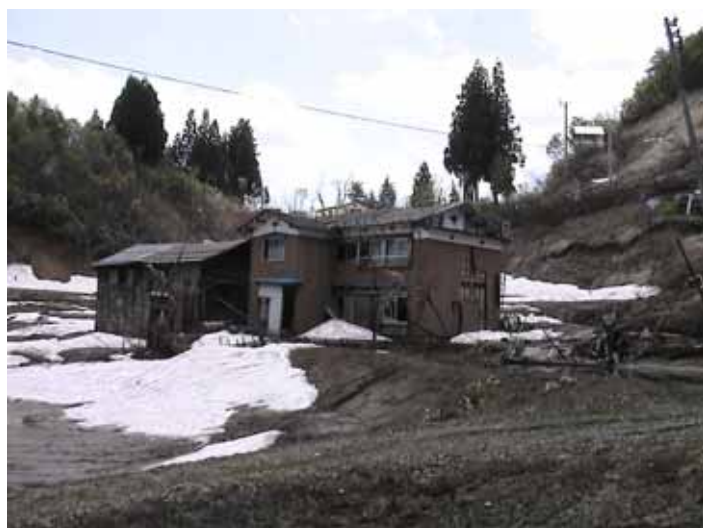
23-12池谷DSC00093.JPG  
2005/05/14 11:09:25  
水田と同じ地盤上の家屋（外見上ひどく変形していない）

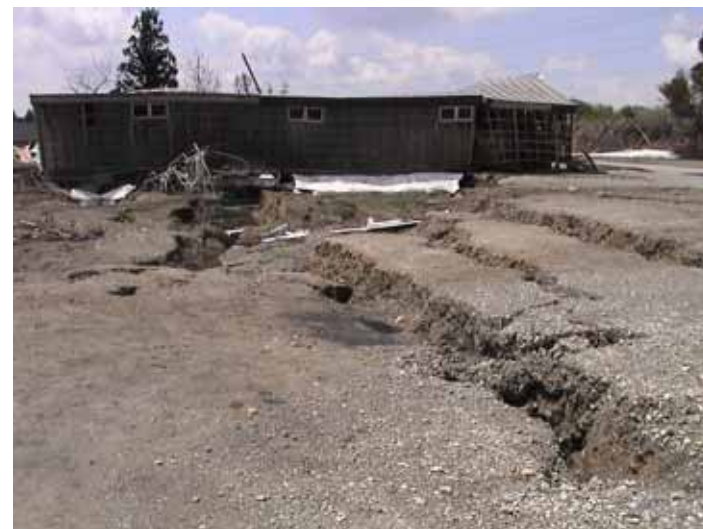
25-01榎木南平DSC00002.JPG  
2005/05/14 10:11:34  
崖地上の地盤にはクラックが多数発達

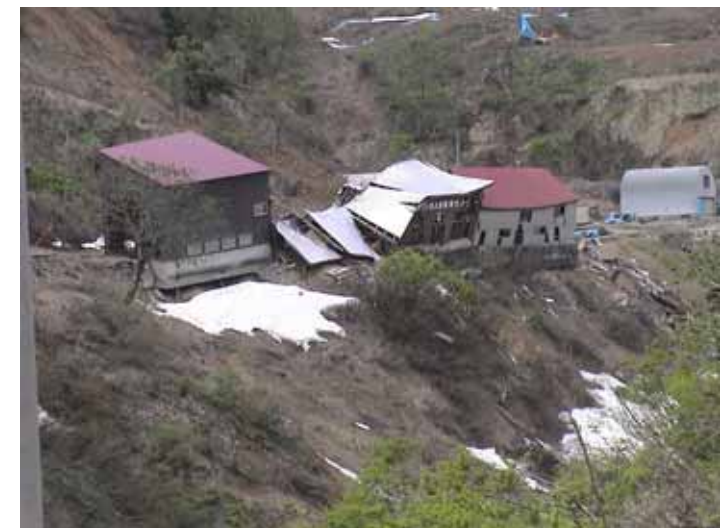
30-01 大久保DSC00107.JPG  
2005/05/14 11:17:17  
急崖部地盤が変形

写真の撮影は、変状が著しい家屋・宅地だけでなく、外見上変状がほとんど見当たらないものも対象にしています。  
地すべりが発生しそれに巻き込まれている箇所を除けば、変状のある箇所の大半は盛土部か、急崖部に位置しています。

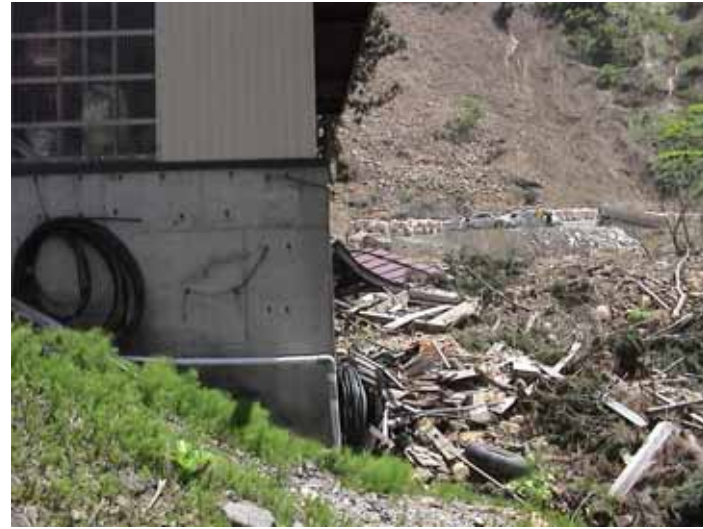
31-06竹沢DSC00143.JPG  
2005/05/14 11:51:25  
外見上変状無し

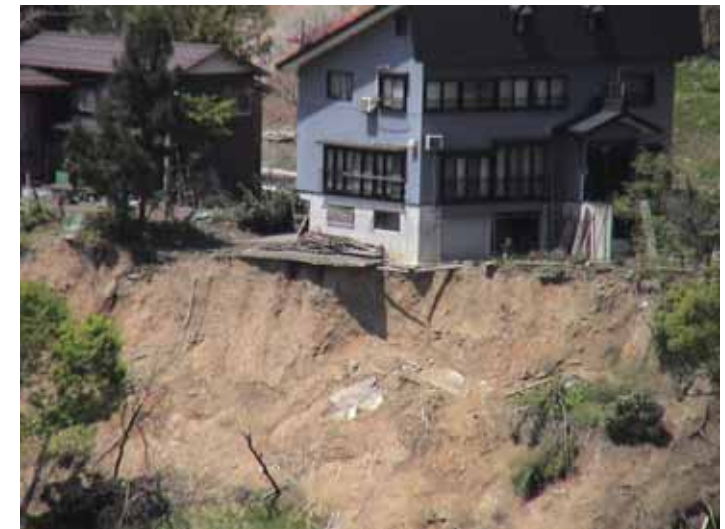
31-24竹沢地すべりDSC00176.JPG  
2005/05/14 12:01:36  
地すべりの頭部滑落崖

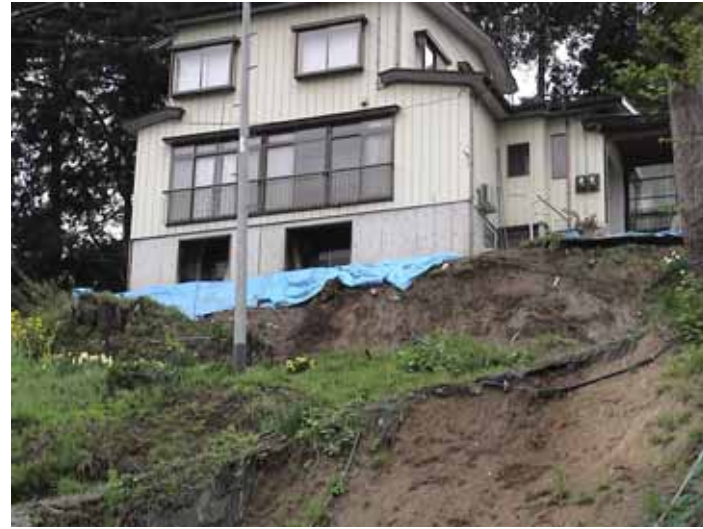
52-01蓬平DSC00059.JPG  
2005/05/15 10:19:21  
この家は地すべりの外側にある

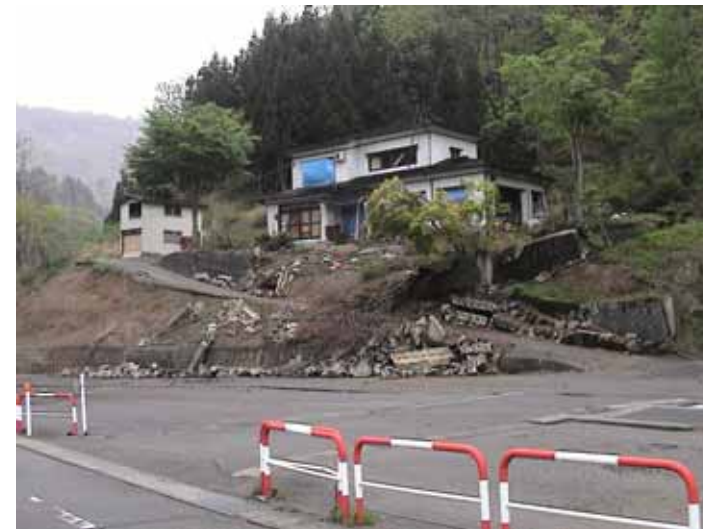
53-01太田川DSC00072.JPG  
2005/05/15 10:30:01  
盛土地盤が変形

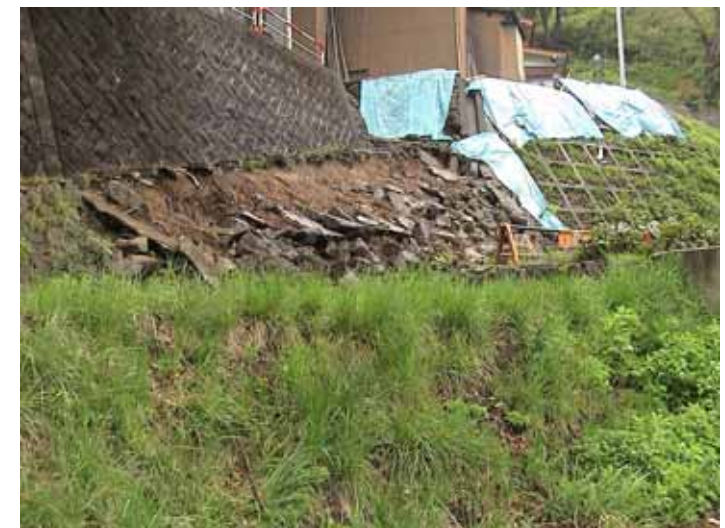
55-04濁沢空石積DSC00119.JPG  
2005/05/15 10:58:50

空石積の崩壊

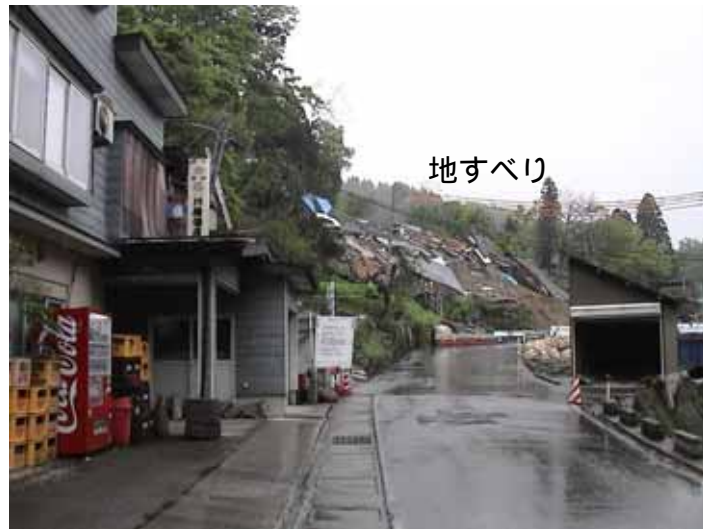
55-05濁沢2名死亡地すべりDSC00122.JPG  
2005/05/15 11:01:02

地すべりに巻き込まれた家屋
