Pore water pressure estimation method at the time of the collapse using a Soil Strength Probe

Hidemasa OHTA

Ohta Geo-Research Co., Ltd., Japan

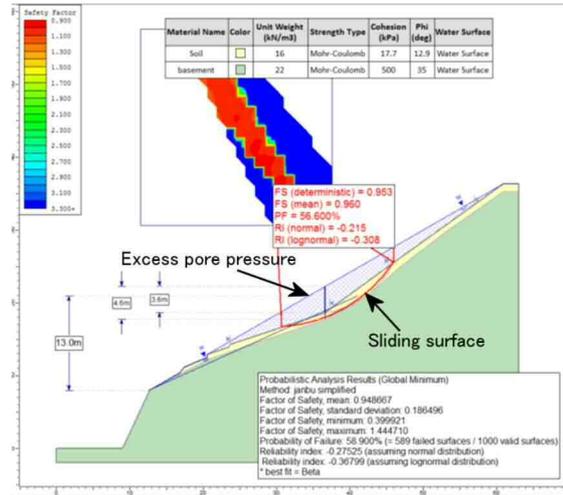
(a) Inverse analysis, Yokosuka 2012

When Fs values were calculated to be less than 1, groundwater head was higher than the ground surface. In other words, underground water pressure, had become excess pore water pressure state (fig.8).

Fig.8 Examples of inverse analysis
