# 旧山古志村付近の宅地地盤状況写真

調査期間：2005年5月13-15日  
調査者：太田英将@太田ジオリサーチ  
(土木学会斜面工学研究小委員会の調査)

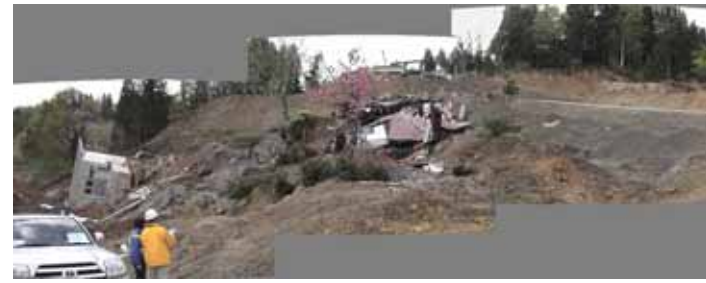
12-01寺野家屋倒壊Stitched\_Result.JPG

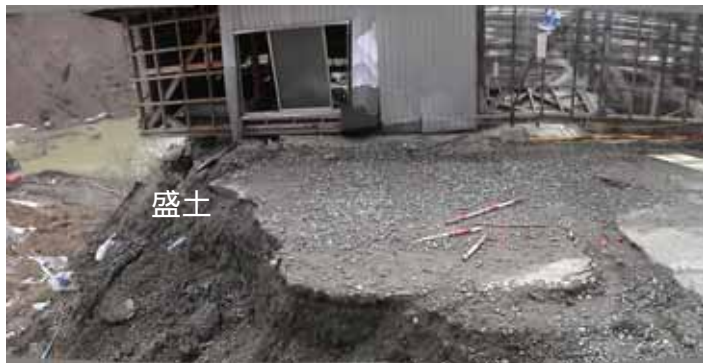
12-03寺野盛土部Stitched\_Result.JPG

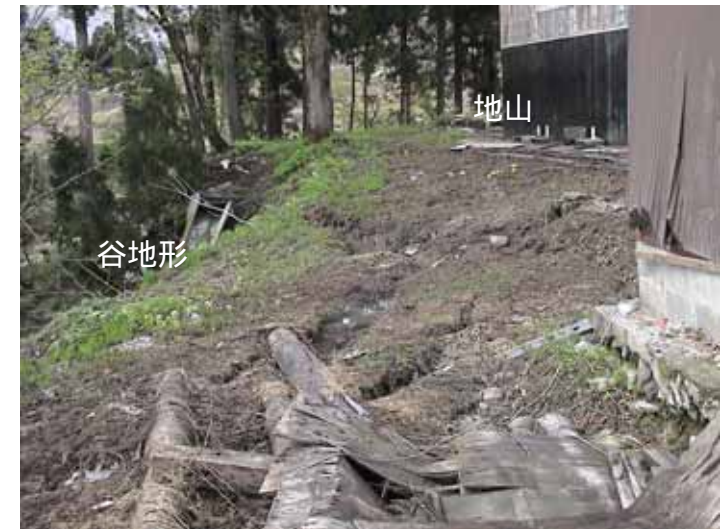
12-06寺野谷地形部DSC00207.JPG  
2005/05/13 15:18:56

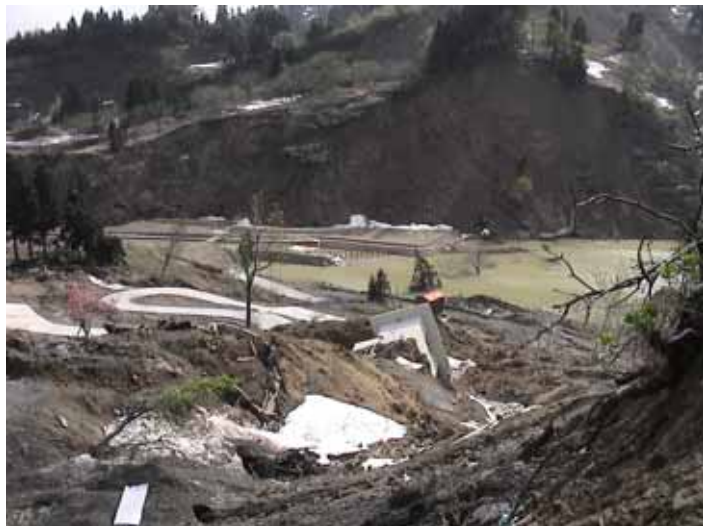
12-07ポンプ場倒壊DSC00208.JPG  
2005/05/13 15:21:35

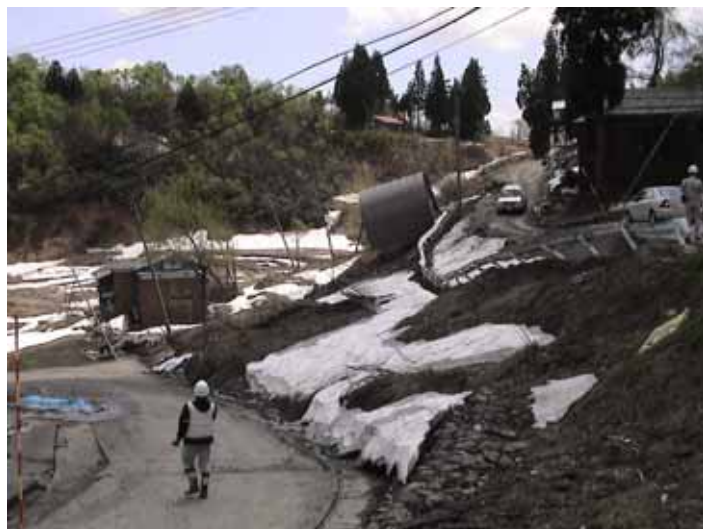
23-03池谷DSC00075.JPG  
2005/05/14 11:02:35  
谷部の盛土上の建物

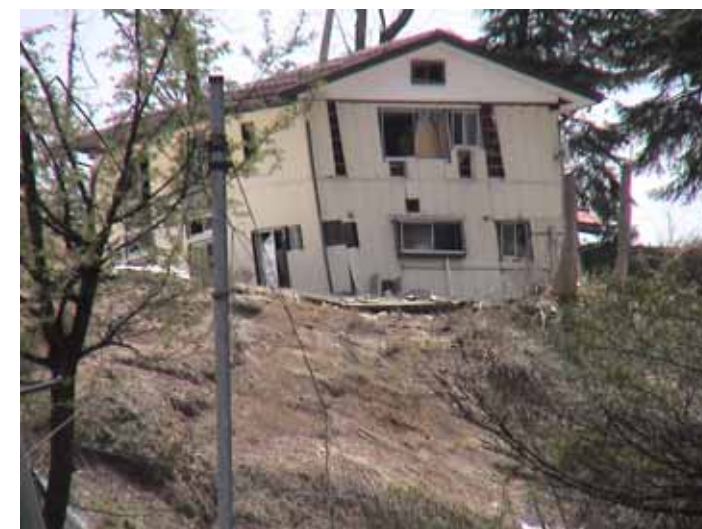
23-09池谷DSC00086.JPG  
2005/05/14 11:08:11  
ブロック積擁壁の盛土部崩壊

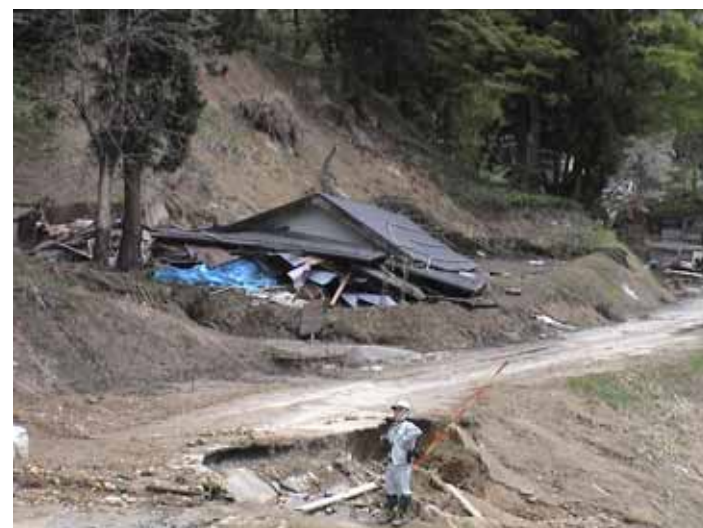
23-12池谷DSC00093.JPG  
2005/05/14 11:09:25  
水田と同じ地盤上の家屋（外見上ひどく変形していない）

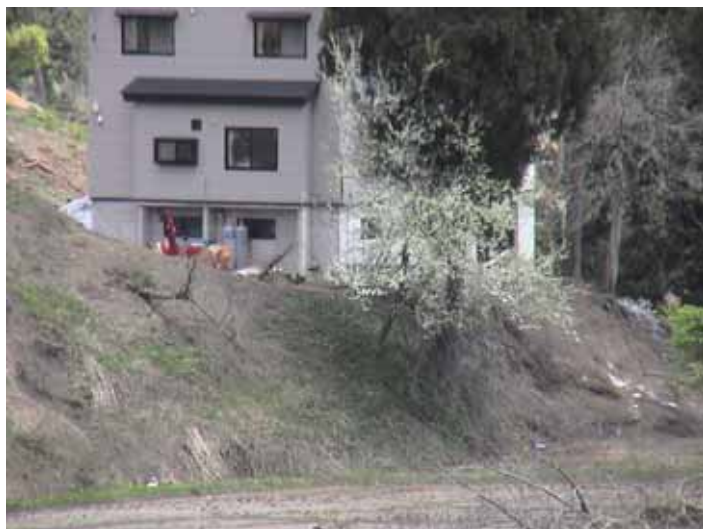
23-14池谷DSC00097.JPG  
2005/05/14 11:10:41  
外見上変形していない

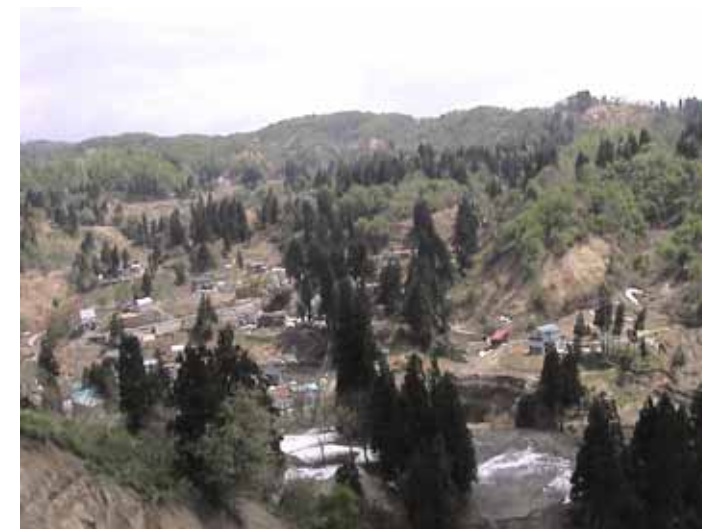
25-01榎木南平DSC00002.JPG  
2005/05/14 10:11:34  
崖地上の地盤にはクラックが多数発達

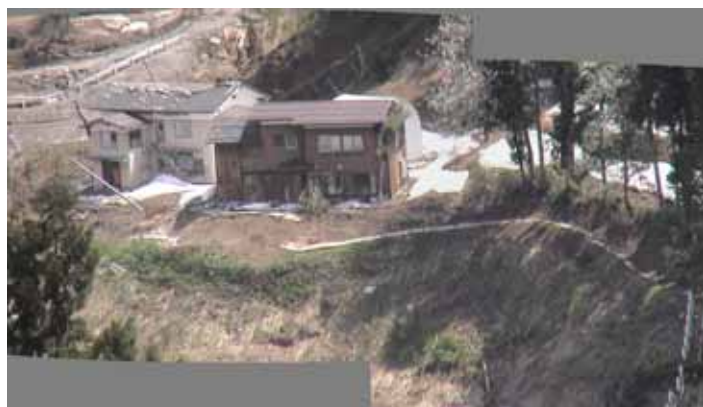
25-03榎木宅地Stitched\_Result.JPG  
急崖部の地盤が崩落

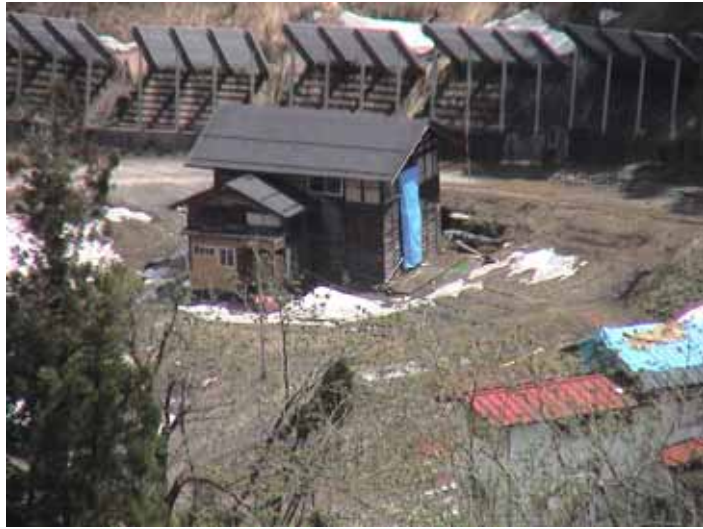
25-10榎木土石流堆積物上SC00027.JPG  
2005/05/14 10:21:42

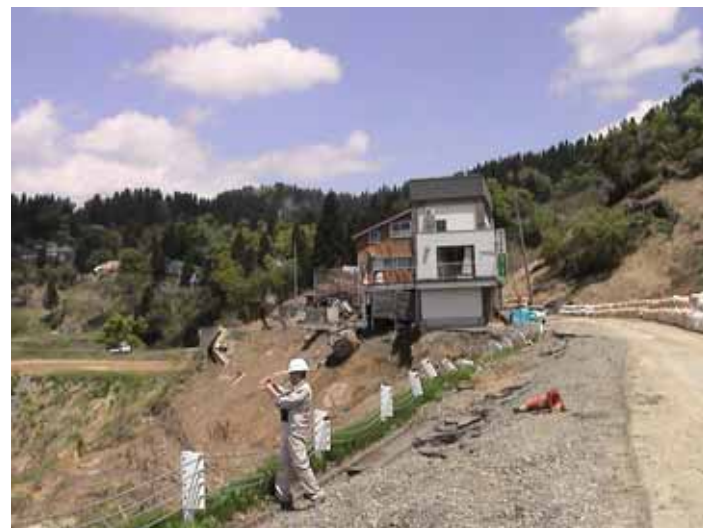
31-14竹沢DSC00157.JPG  
2005/05/14 11:58:17  
盛土部の崩落

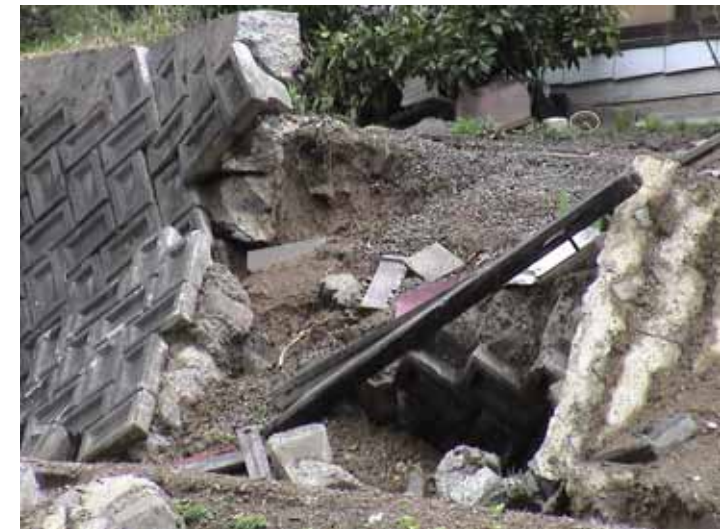
53-01太田川DSC00072.JPG  
2005/05/15 10:30:01  
盛土地盤が変形

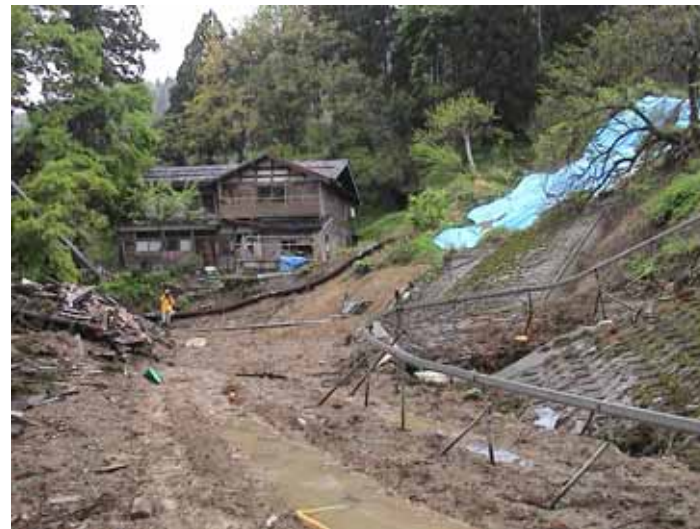
55-05濁沢2名死亡地すべりDSC00122.JPG  
2005/05/15 11:01:02

地すべりに巻き込まれた家屋

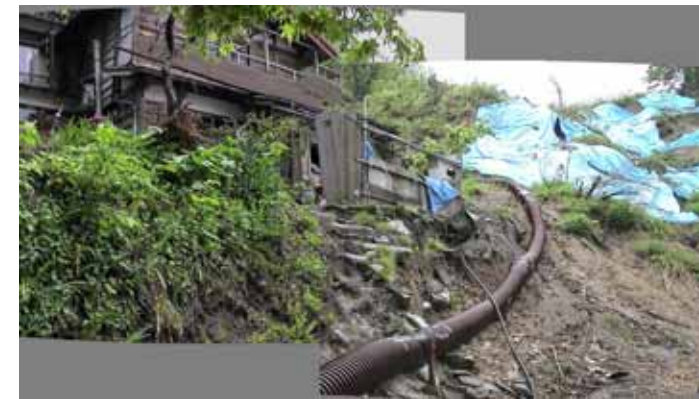
55-06濁沢2名死亡頭部DSC00158.JPG  
2005/05/15 11:18:28

奥の家屋は地すべり外
